## EMODnet Sea-basin Checkpoints Tender no MARE/2014/09-Lot3

# EMODNET Oil Platform Leak Bulletin

(24hour report)

Date: 11/05/2016

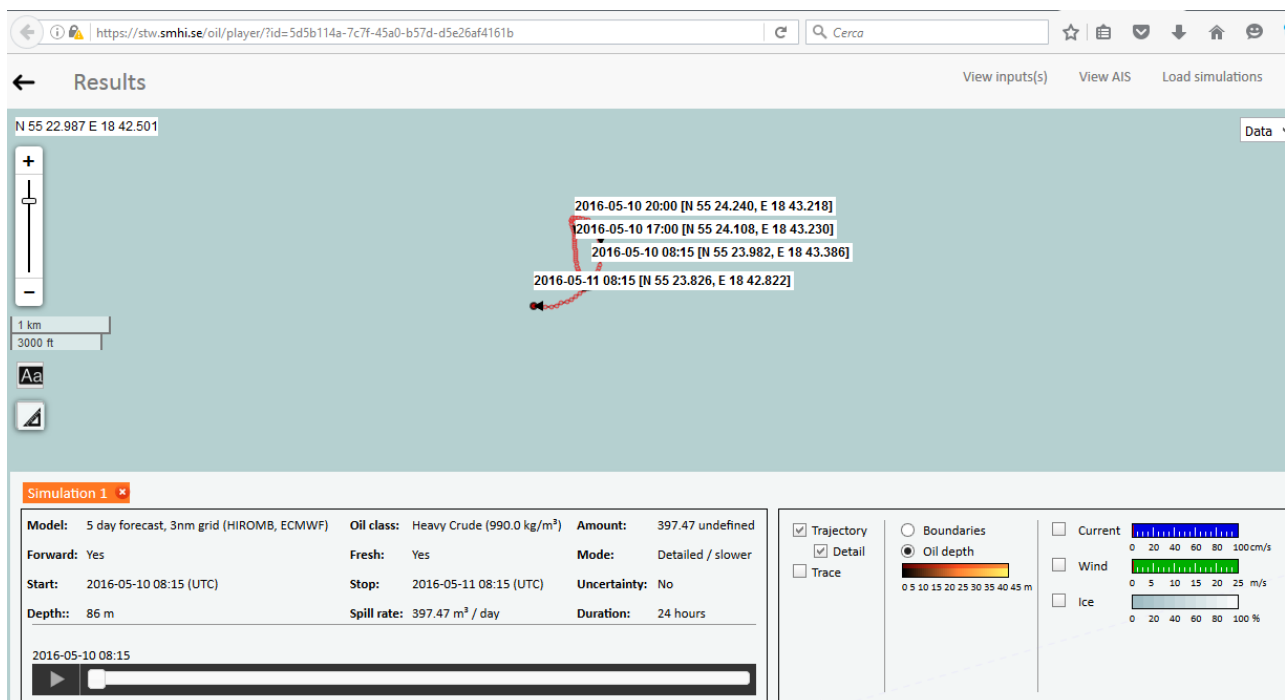
Figure 6. oil leak trajectory in 24h

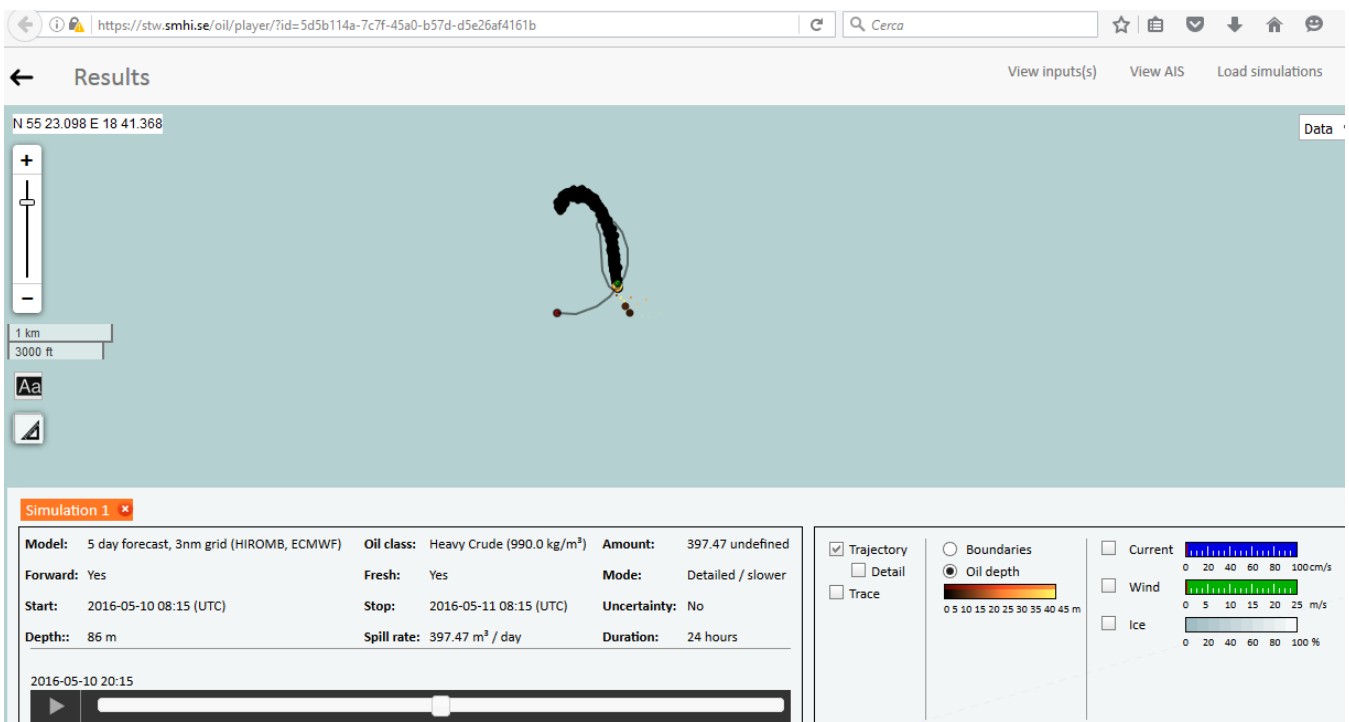
Figure 8. oil leak simulation after 12h 201605102015CET

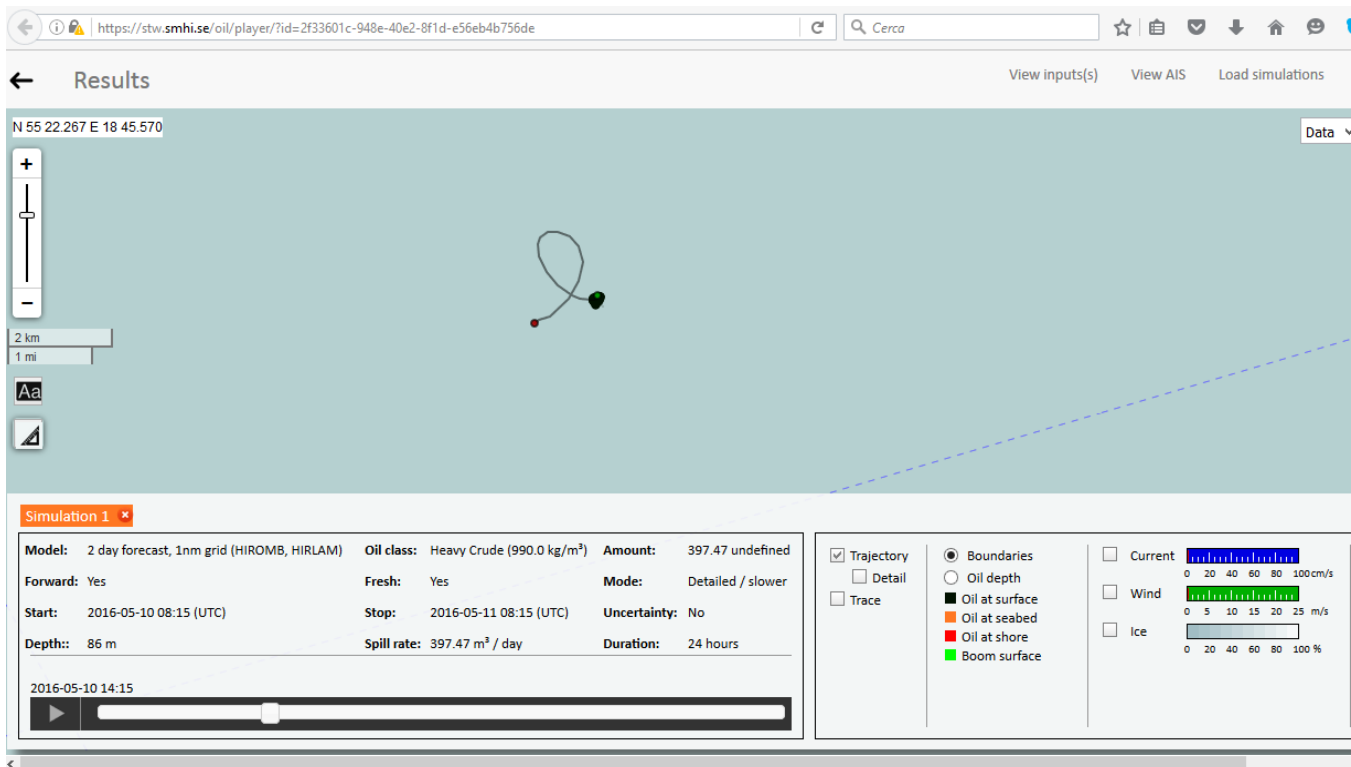
Figure 12. oil leak simulation after 6h 201605101415CET

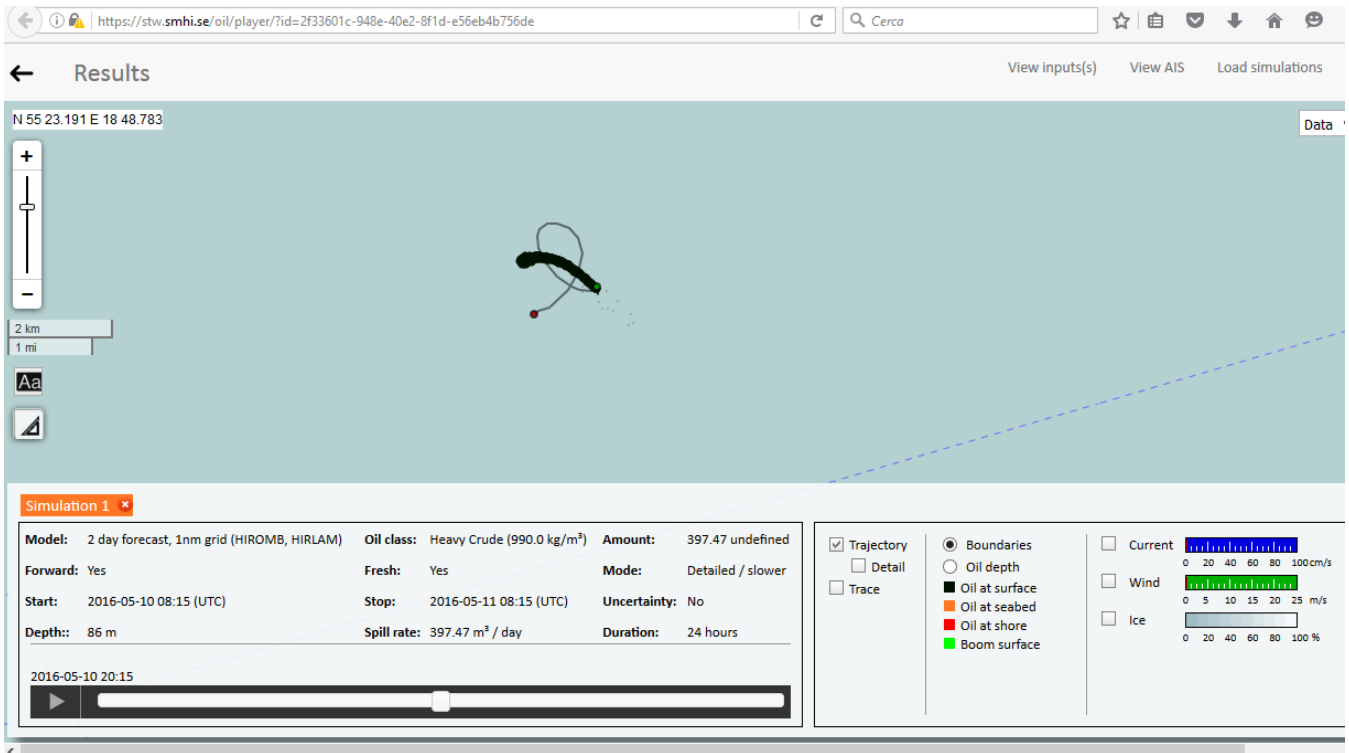
Figure 13. oil leak simulation after 12h 201605102015CET

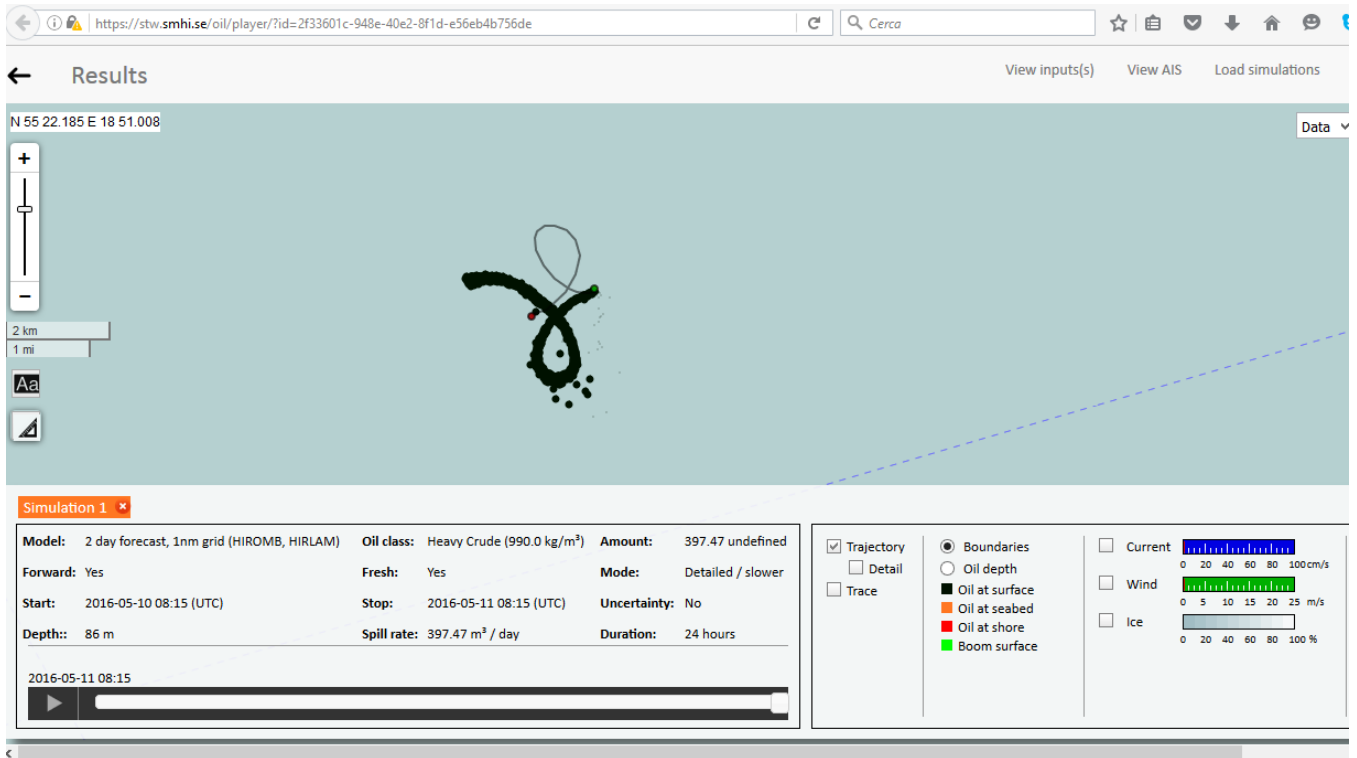
Figure 15. oil leak simulation after 24h 201605110815CET

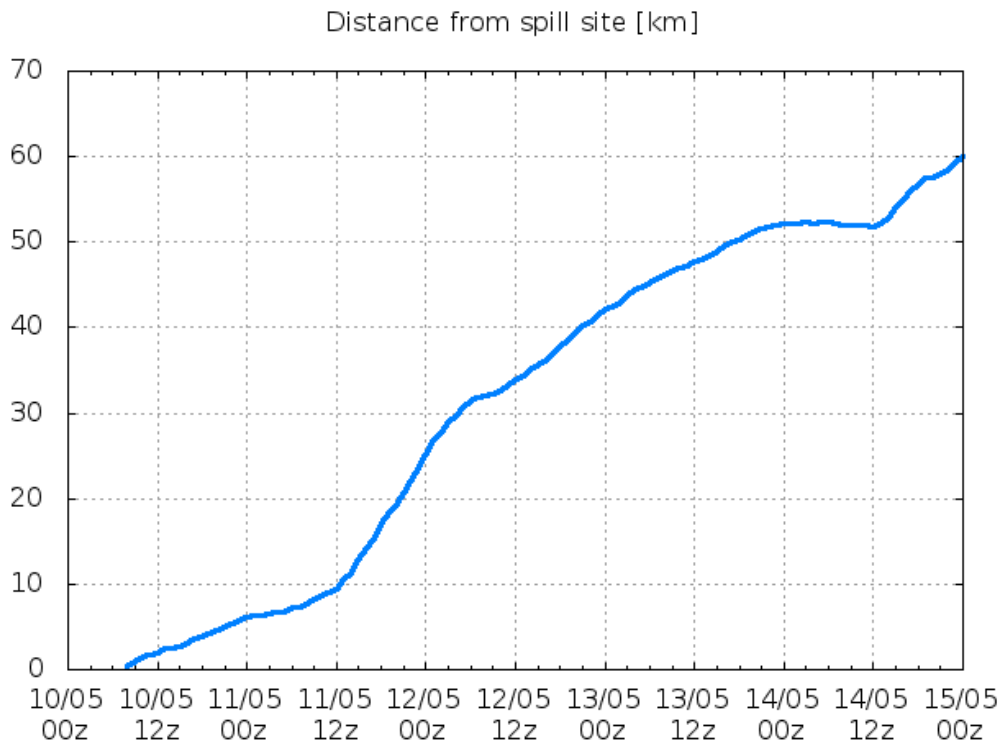
DMI has made a 96hour forecast by using a mixed HIRLAM and ECMWF weather forcing. Due to the calm weather condition, the oil does not drift too far from the incident site. Figure 16 shows the drift. The results show that during the first day, the oil drifts less than 10km, and at 96h after the spill, the oil will drift away about 60km.

**Figure 16. Distance of the oil drifting away from the spill site**

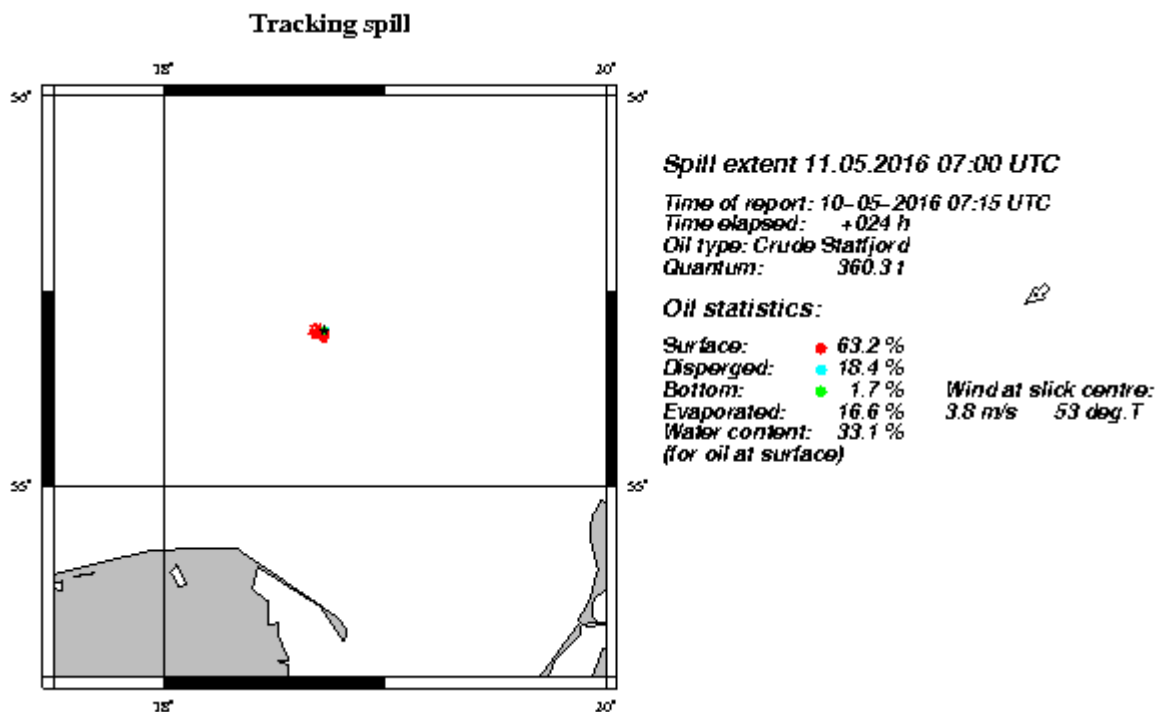
Figure 19. oil leak simulation after 20.45h 201605110700CET

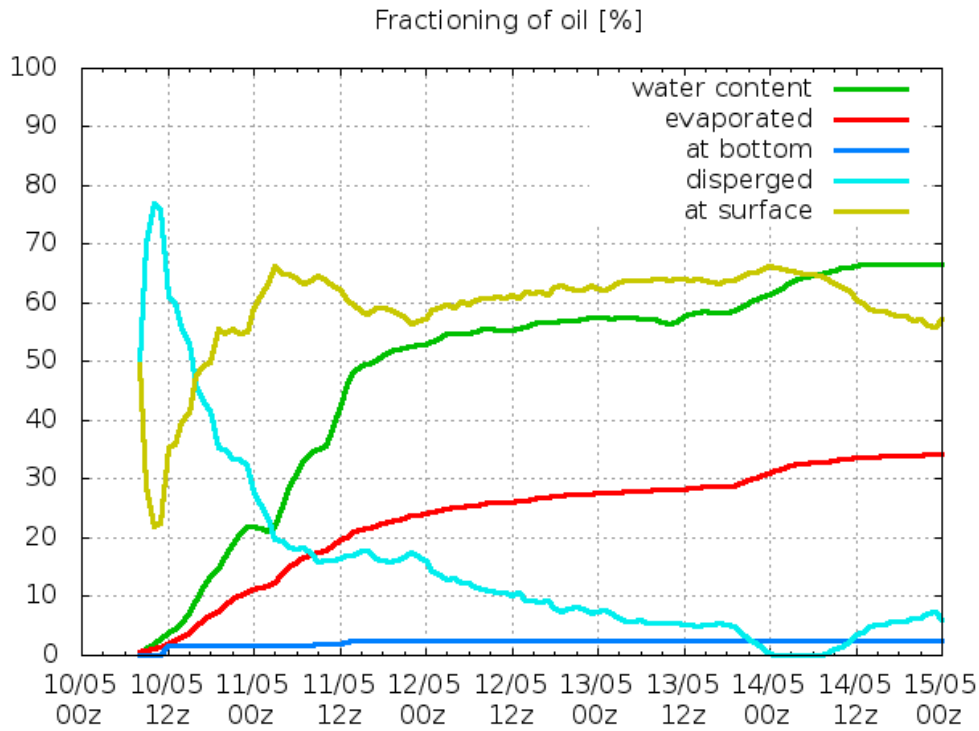
As this is a spill at sea bottom, the vertical movement of the oil is also important. The total percentage of the oil at surface and bottom are shown in Figure 20. It is shown that major amount of oil moving to the surface in the first 24hours.

Figure 20. Percentage of oil characters in the 96-hour period after the oil spill

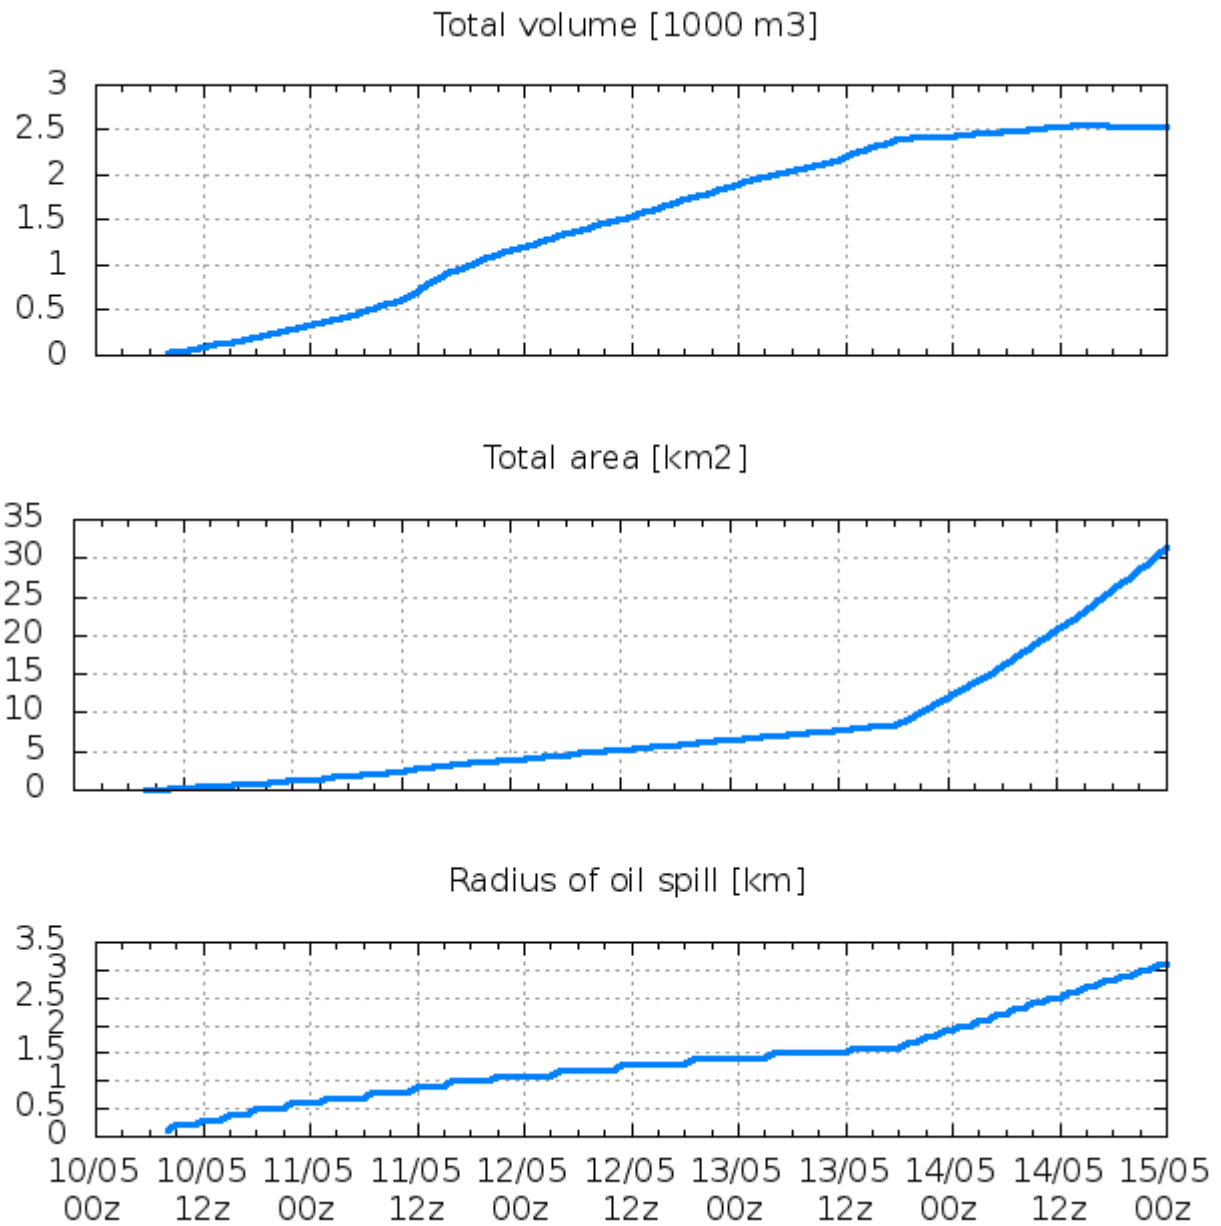
Figure 21 and Figure 22 are showing other oil characters e.g. volume etc

Figure 21. Forecast of Oil characteristics

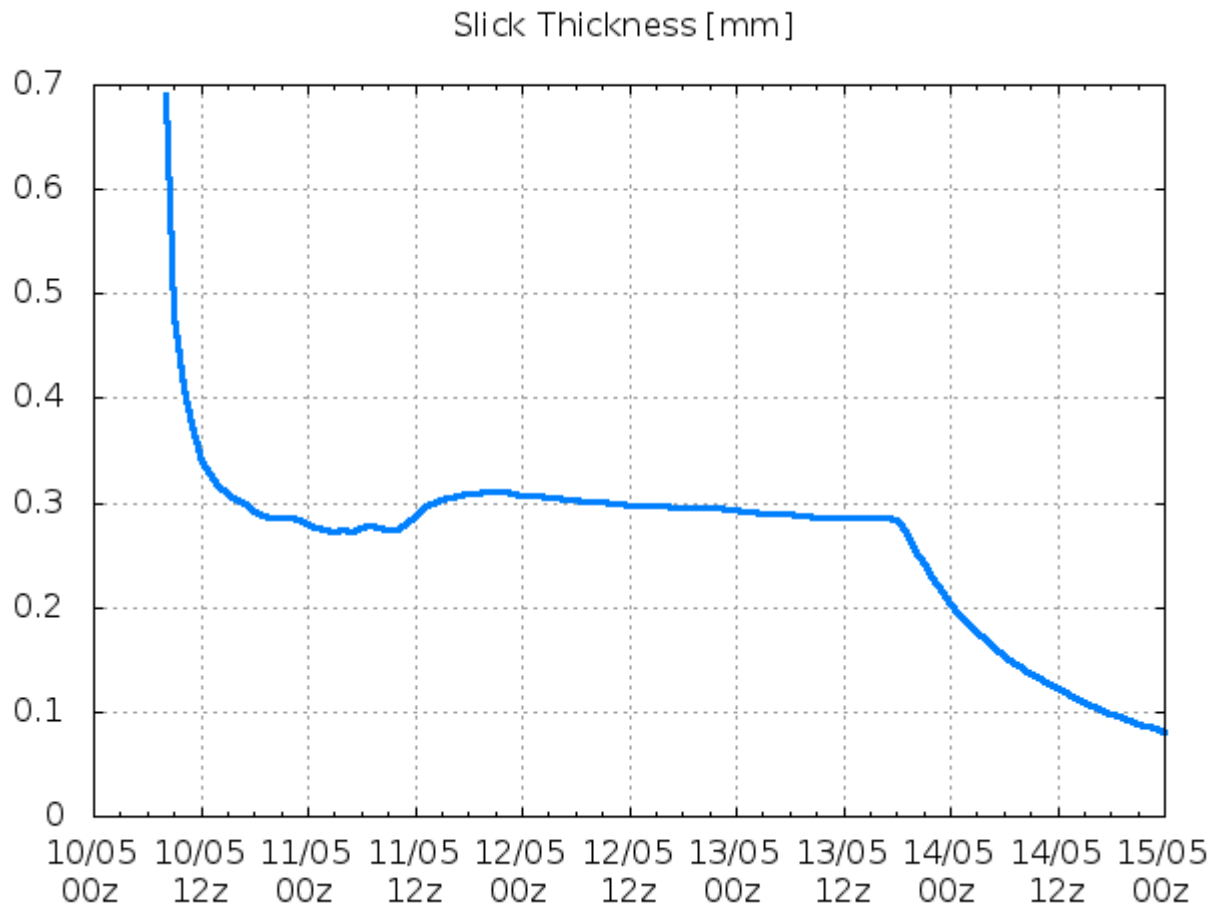
Figure 22. Forecast of Oil characteristics (continue)
